# MANAGEMENT PLAN FOR THE MEDIEVAL FISHERY AND WARREN IN HOME WOOD

Monument No SM29423

**This plan is a renewal of the current management plan that expired on 28 Feb 2006**

**Coverage of this plan is for the period 28 February 2006 – 28 February 2011**

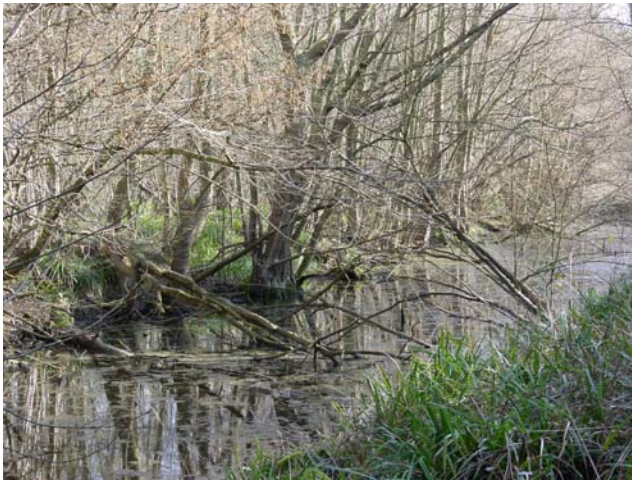
*Removal of all invasive Sycamore trees is required to preserve and restore the monument.*

*The western outer moat*

Where possible, after felling, sycamore trees will be removed, whole, but some small timber stacks may be left if extraction proves difficult or likely to cause damage to the site. Burning of any timber would not be permitted on site. No machinery would be permitted to the three central islands because of the sensitivity of the earth works. Instead, trees need to be removed, pole length, using cable winch extraction from outside the sensitive area.

Sycamore stumps must not be removed but treated to prevent re-growth. During this operation, prevention of water contamination will need to be considered before treatment is applied and treatment must be carried out within a specified time period after felling.

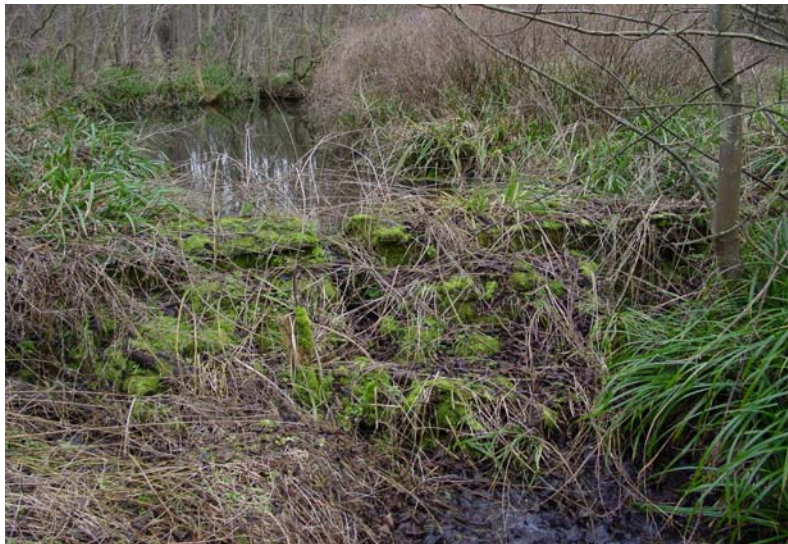
The brick dam to the south west of the site (marked B on Diagram 1) continues to cause concern as this structure maintains the water level over a majority of the outer moat. The vegetation covering the dam and over-spill drain needs to be removed (*see picture below*) to

*The south-west Dam – Jan 2005*

assist inspection by a qualified civil engineer. Any remedial recommendations to repair and/or maintain the dam will need to be agreed with English Heritage, and submitted in the form of an amendment to this plan.

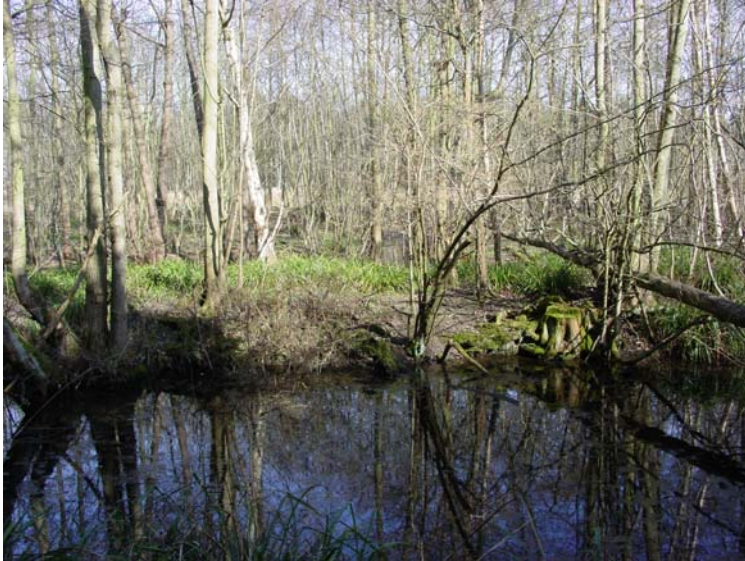
*Tree cover on the internal fishponds*

Removal of tertiary deposits using a suction pump, or mechanical digger, is required to improve water levels. Whatever method is adopted, the objective is to re-form the original moat profile without damaging the site. This work needs to be supervised by a qualified Wetland Archaeologist and the debris inspected for artefacts as the work proceeds.

The Alder (*Alnus glutinosa*) trees would be coppiced and the lop and tops removed from sensitive areas and watercourses. A likely consequence of reducing the tree cover is incursion by woody weeds, coarse grasses and sedge, which needs to be controlled. Cutting by hand is currently the only feasible option, within the confines of the sensitive fish pond complex.
